PRS EOT - End-of-Tenancy Inspection

| 4 Oct 2022 / Joanna Jarosik (Joanna) | | | Complete | | |

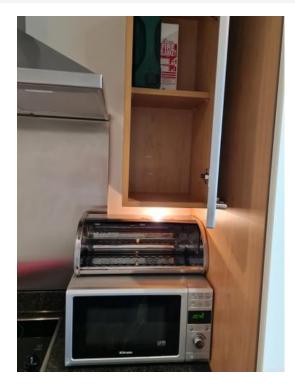
Photo 1

The missing fire blanket (from the kitchen cabinet) was supplied.

| Complete Assignee Joanna Jarosik Priority High Due 17.10. | 2022 21:07 UTC | |
|---|---|--|
| Replace the missing fire blanket (in the kitchen cabinet). | | |

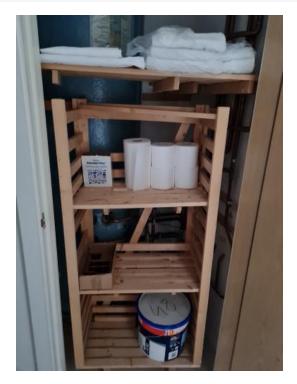
Photo 2

Furniture washed down & cleaned. The hot press was prepared following the Playbook. Welcome items were placed throughout the living room according to the Playbook.

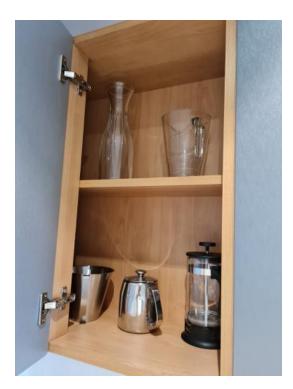
Photo 16

Furniture cleaned & prepared for tenancy. The missing kitchen pedal bin & bing bags were replaced. All kitchen items & appliances were prepared for tenancy. Consumables were supplied following the agreed Playbook.

| Complete Assignee Joanna Jarosik Priority High Due 17.10.2 | 2022 21:30 UTC | |
|---|---|--|
| Replace the missing kitchen pedal bin (and apply a new bin bag). | | |
| Replace the missing bin bags from the dedicated kitchen cabinet. | | |

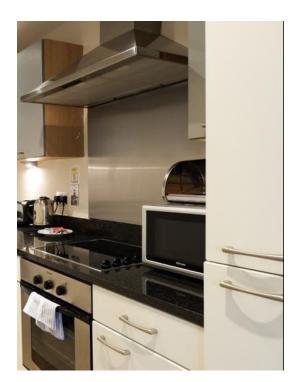
Photo 26

All appliances, including oven, cooker, hob, fridge, microwave, kettle & toaster, were wiped & prepared for new tenancy.

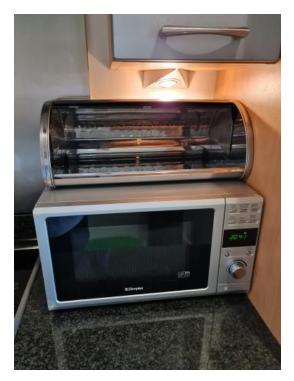
Photo 30

Deep cleaned & tested. Ready for tenancy.
