PRS EOT - End-of-Tenancy Inspection

28 Oct 2020 / Martin Linnane

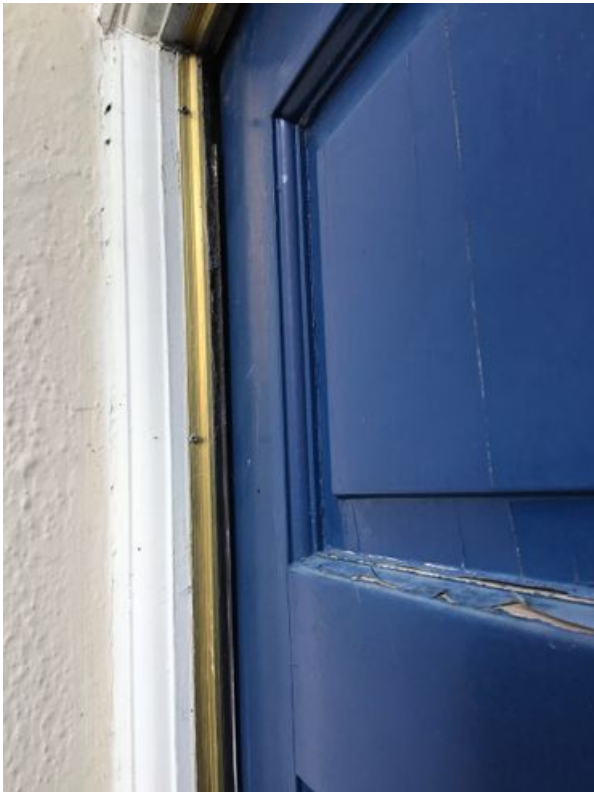
Photo 1

Some warping in the door itself has created draft areas which have already been fitted with draft excluders.

Unfortunately the door has warped and thus incredibly difficult to seal with draught excluders. Remedy is to change door.

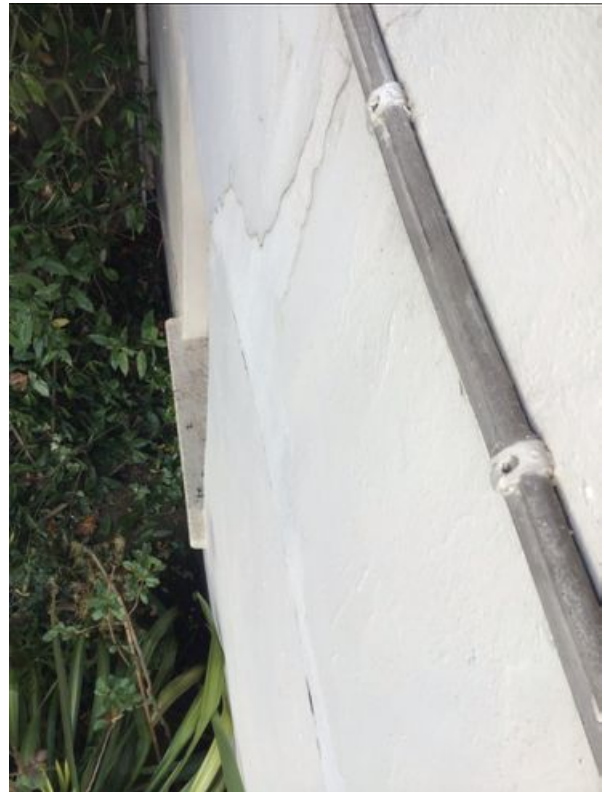
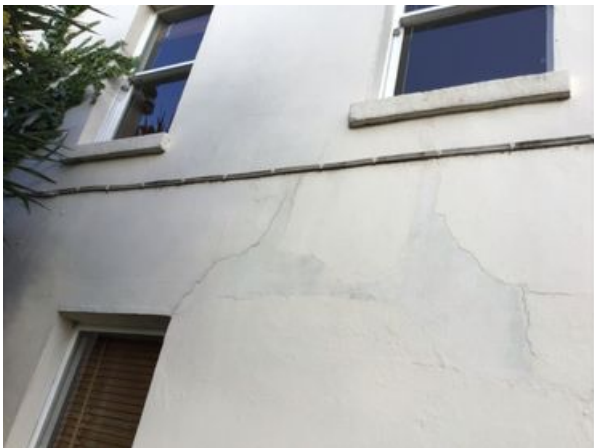
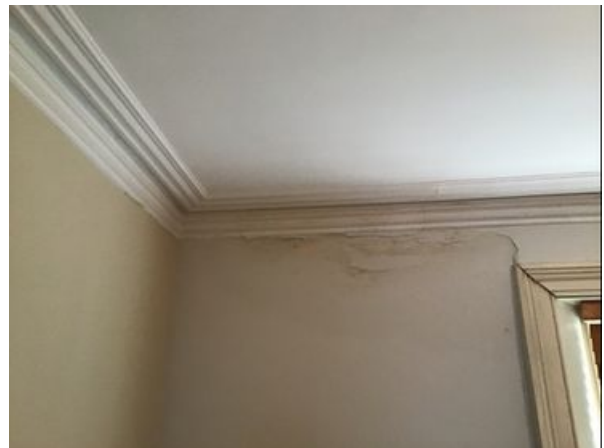
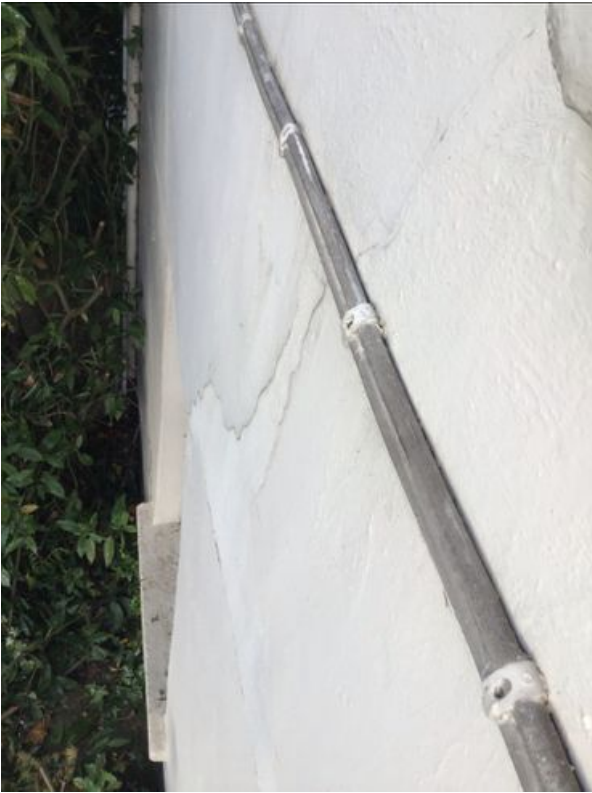
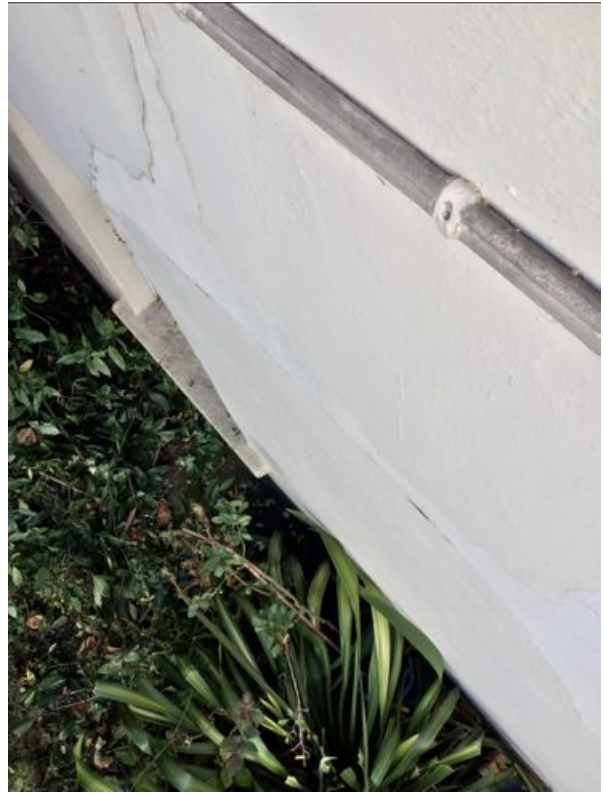
Both garden and path to the front of the house require maintenance and general tidying up. The original wrought iron railings are falling away due to broken wall.

There is an issue with water ingress on the front facade of the house. There is a section of plaster that shows signs of cracking and blowing and it is my view that water is penetrating these cracks and becoming apparent in the living room.

This has been repaired previously but unfortunately hasn't remedied the problem. It's our opinion that in order to stop this ingress that a large section of the plaster is hacked off and made good.

Hack off existing plaster until you reach solidly adhered plaster around the area. Remove all loose material and treat with a upvc liquid to create bond to the masonry then plaster in layers until you've achieved a well bonded finish coat. Then paint.

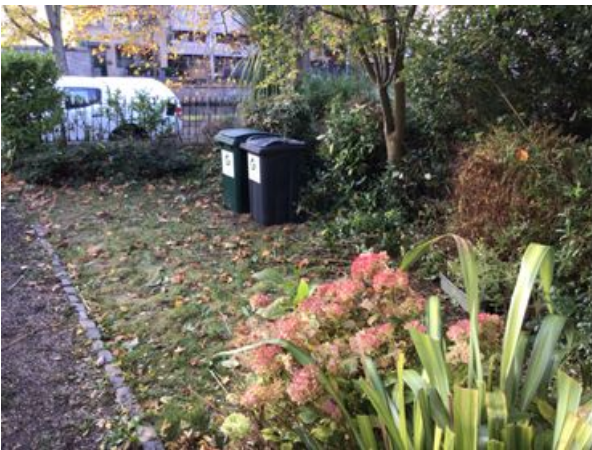
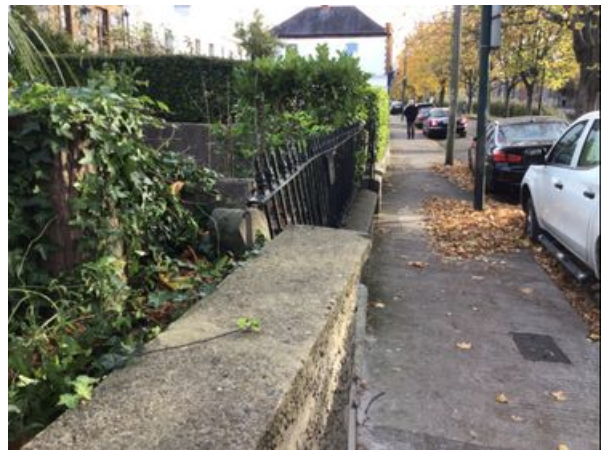
Garden requires tidying up and the railings require repairs.

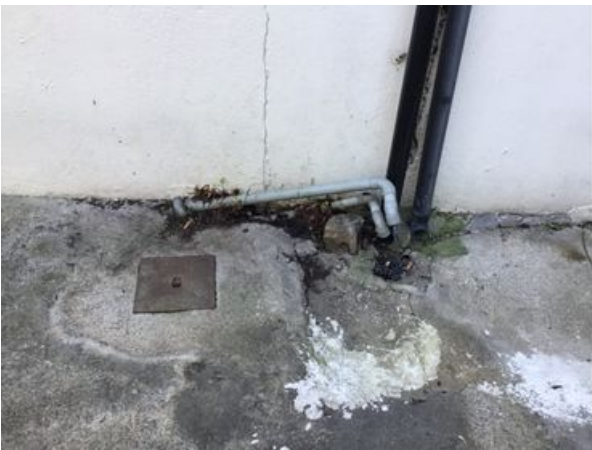
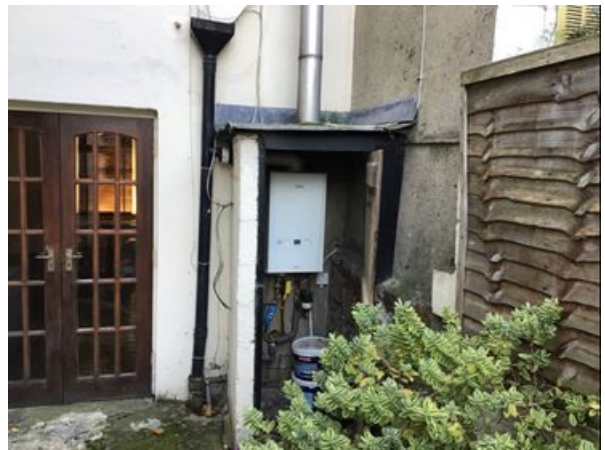
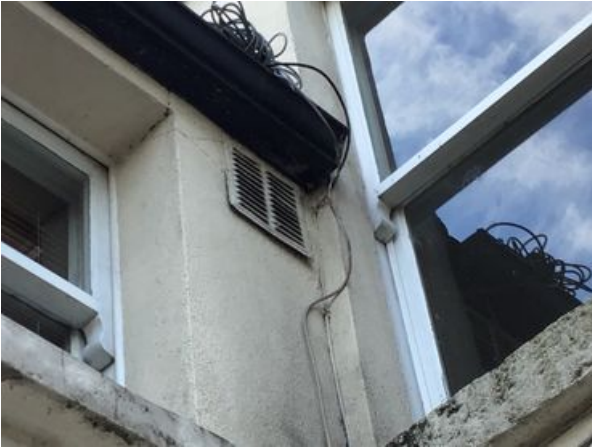
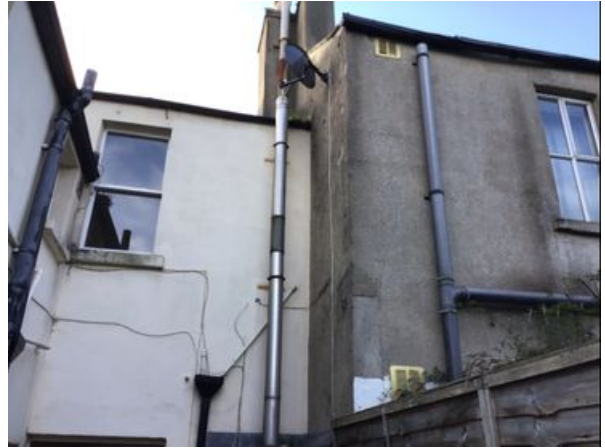
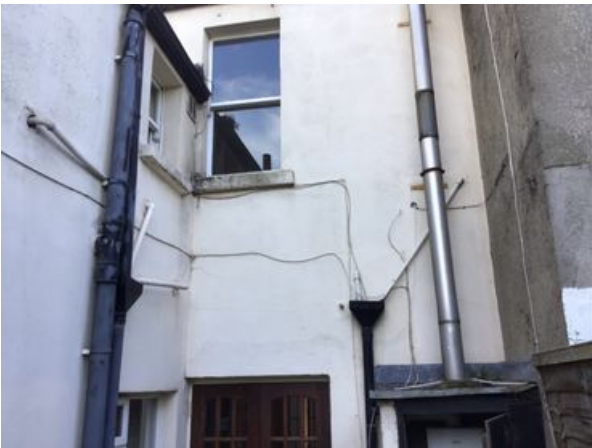
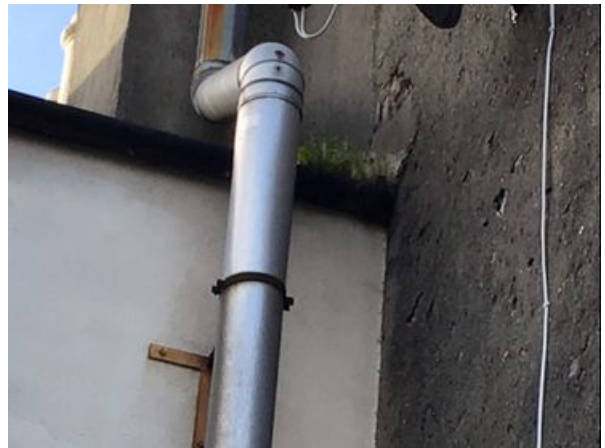
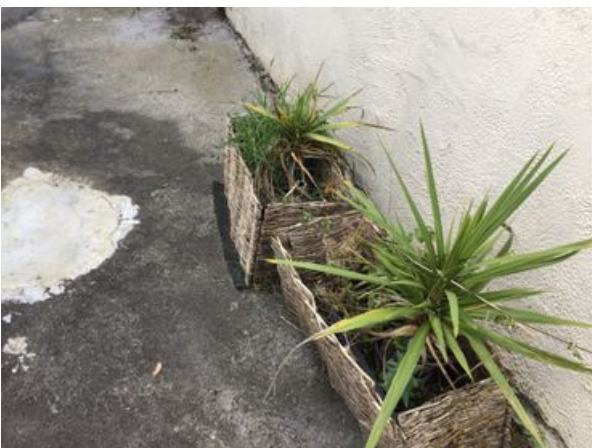
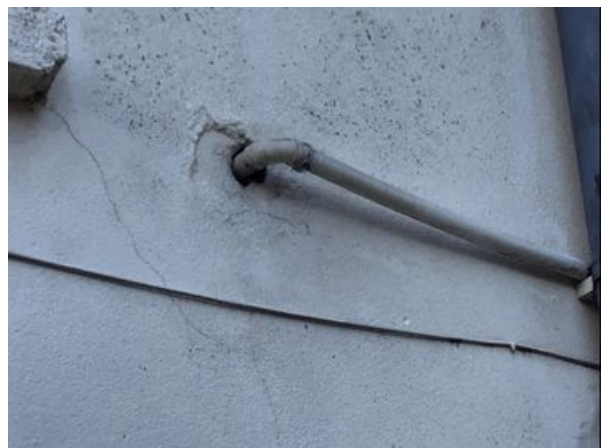
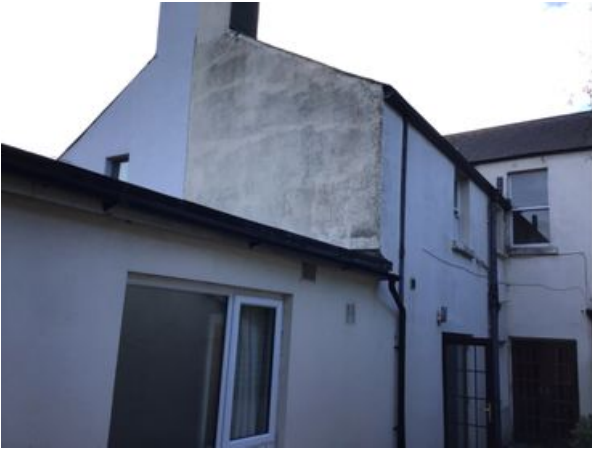
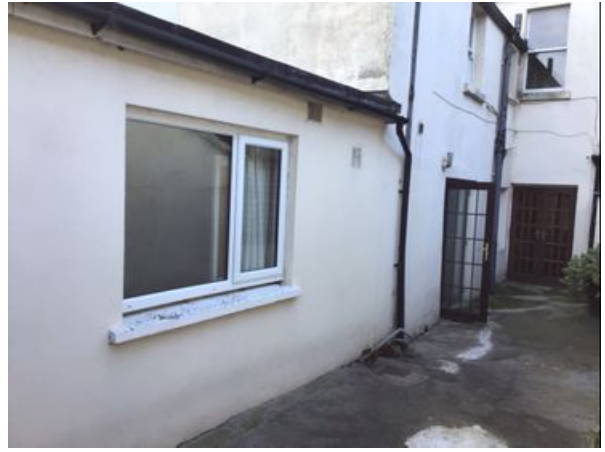
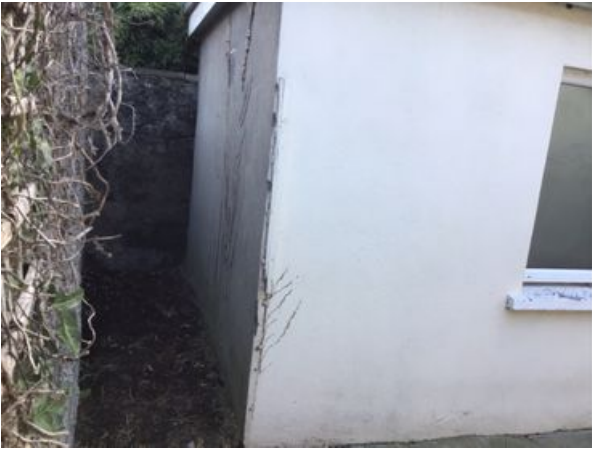
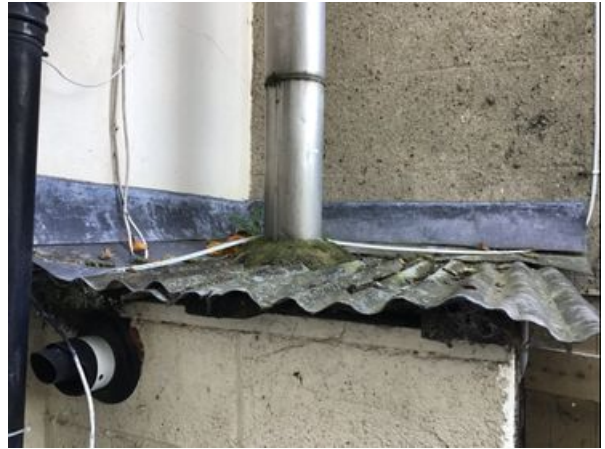
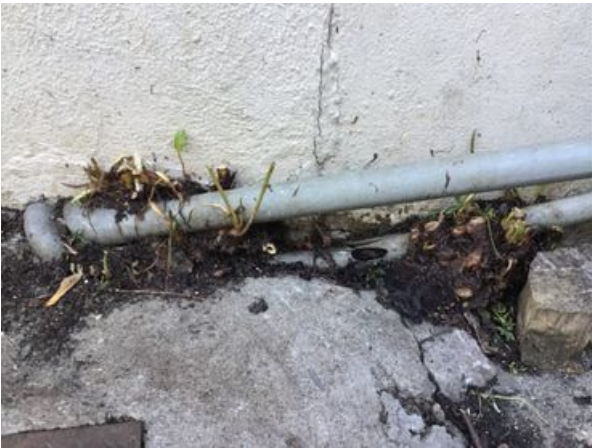
Rear yard area, fix broken waste pipes, remove untidy obsolete cabling off walls, fill hole in around pipe masonry, remove existing obsolete flue and brackets from wall and chimney, check gutters, re roof over gas boiler, remove old planters and dispose.

To repair the waste pipes along wall at ground level we need to remove the weeds/plants then break out some of the wall and get access to the existing pipes to make connections. Then fix them in position and make good the masonry.

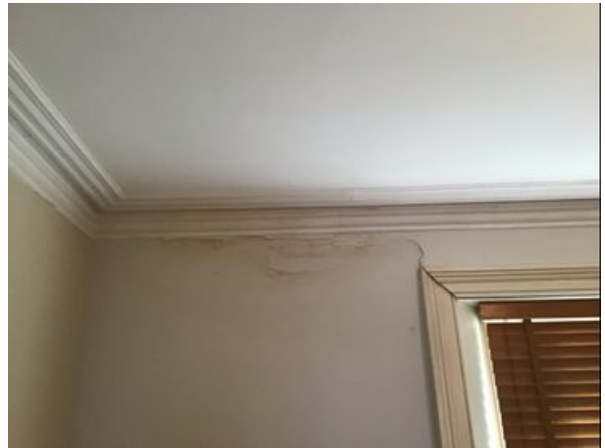
Photo 22

Requires painting and stain retarding in area where leak is apparent.

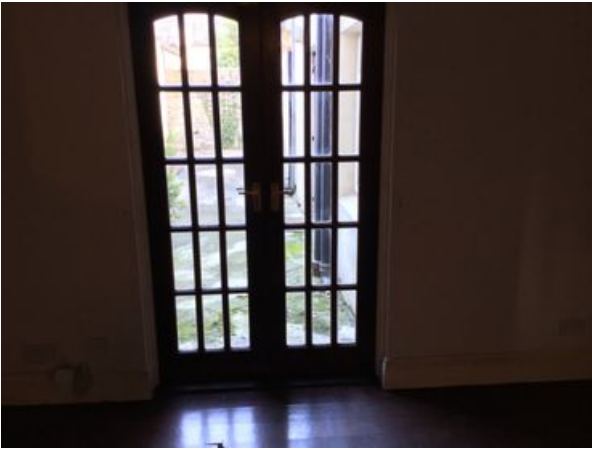
Photo 23

Internal doors are good and the window in the living room. The french type doors leading out to the rear yard is single glazed and draughty.

Overall the property is quite sound and would benefit from upgrades such as replacement of the french doors. Remedial works for the items listed above will be quoted for separately from this report.

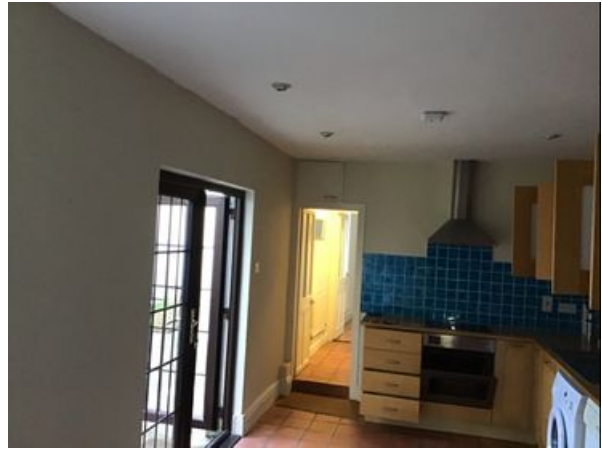
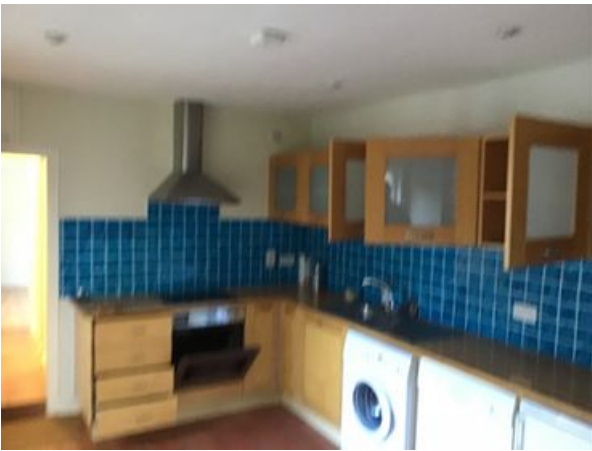
Requires painting.

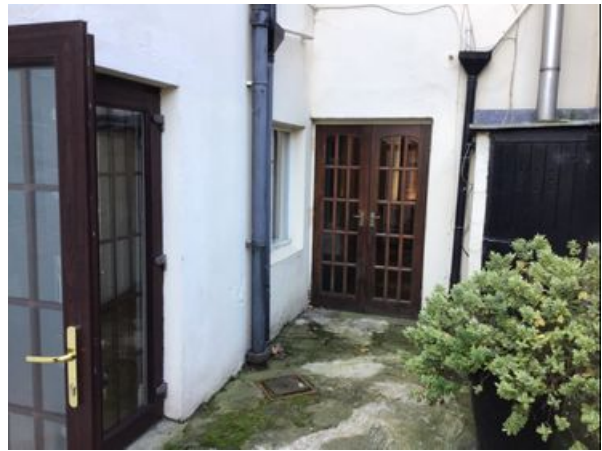
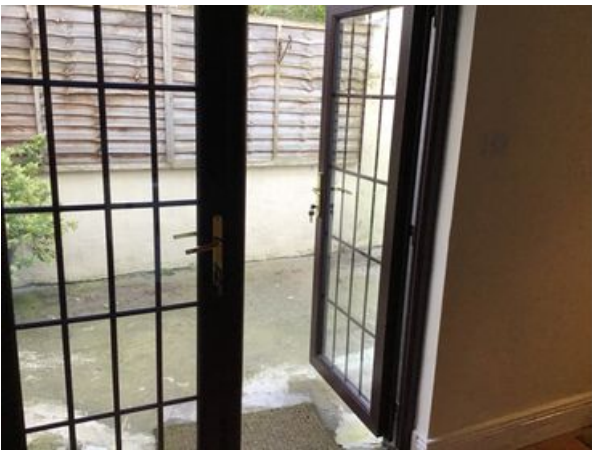
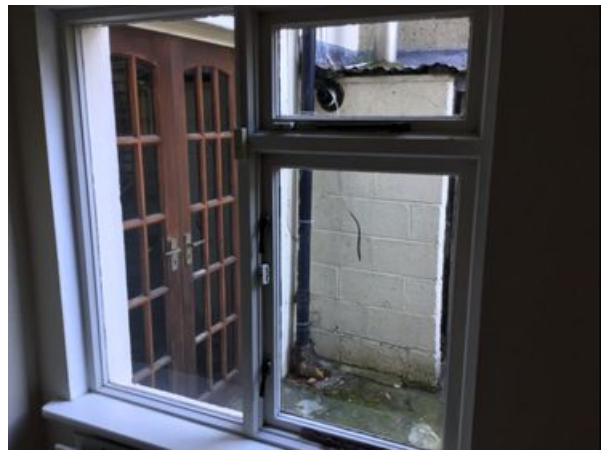
Exterior door leading into rear yard is a new pvc type and there's a single glazed window in the kitchen also.

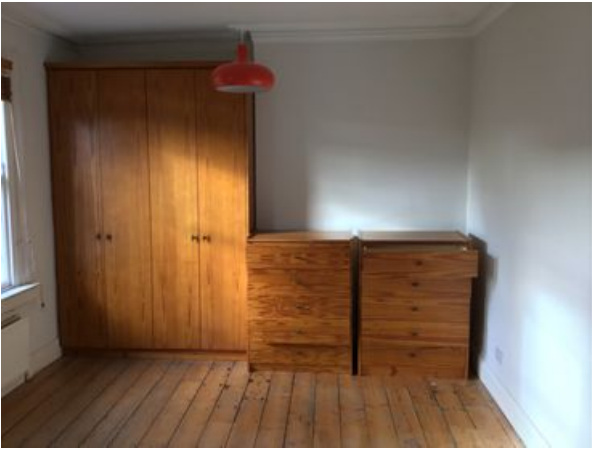
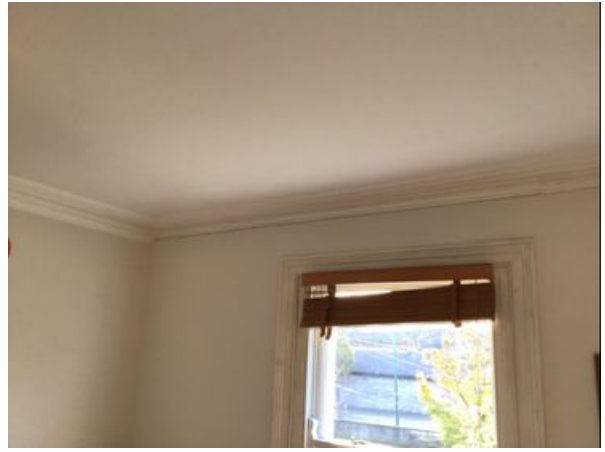
Full paint required. Existing furniture is dated and I'm currently exploring the the possibility of painting same.
