PRS EOT - End-of-Tenancy Inspection

| 4 Oct 2022 / Joanna Jarosik (Joanna) | | | Complete | | |

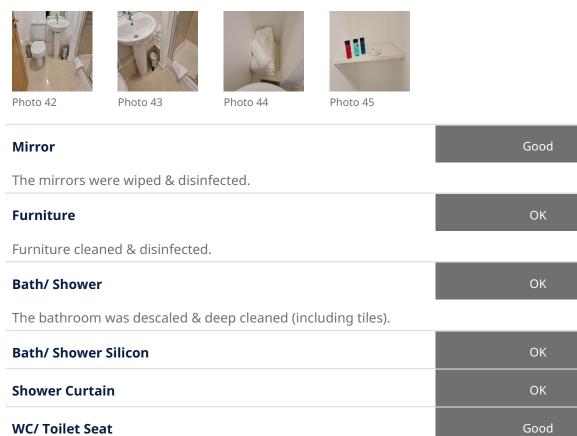
The sink (including the under the sink) was cleaned and polished. Towels & Welcome items were placed across the bathroom following the agreed playbook.

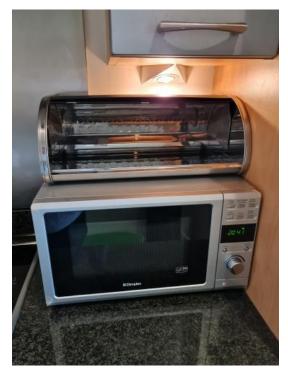
Photo 23

Furniture cleaned & prepared for tenancy. The missing kitchen pedal bin & bing bags were replaced. All kitchen items & appliances were prepared for tenancy. Consumables were supplied following the agreed Playbook.

| Complete Assignee Joanna Jarosik Priority High Due 17.10.2 | 2022 21:30 UTC | |
|---|---|--|
| Replace the missing kitchen pedal bin (and apply a new bin bag). | | |
